Coastal Processes Assessment for Brevard County, Florida, with Special Reference to Test Plaintiffs

by *Nicholas C. Kraus, WES*
Mark R. Byrnes, Applied Coastal Research and Engineering, Inc.
Anne-Lise Lindquist, Consultant

Prepared for U.S. Department of Justice

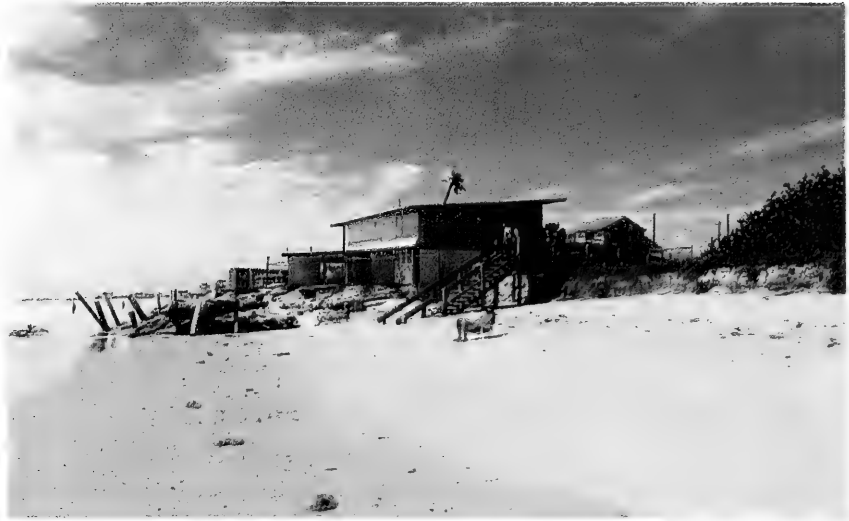
Figure 1-2. Applegate property viewed from the north, May 9, 1996. Note location of neighboring house to landward side relative to Applegate structure (source: N. C. Kraus).

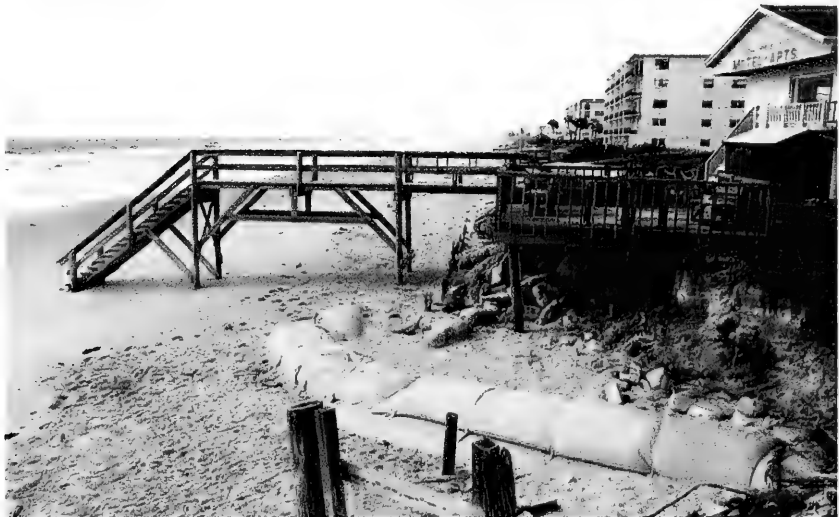
Figure 1-3. Noro and Co. property, May 9, 1996, showing the deteriorated wooden bulkhead and sandbags, as well as storm erosion at the dune face (source: N. C. Kraus).

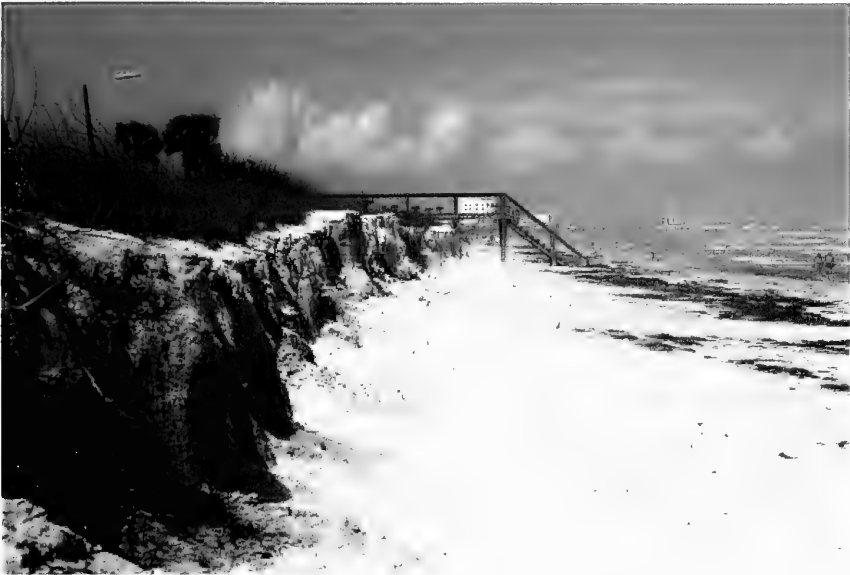
Figure 2-5. View north at Patrick AFB from Officers Club on February 20, 1997, showing storm-induced dune erosion (source: N. C. Kraus).

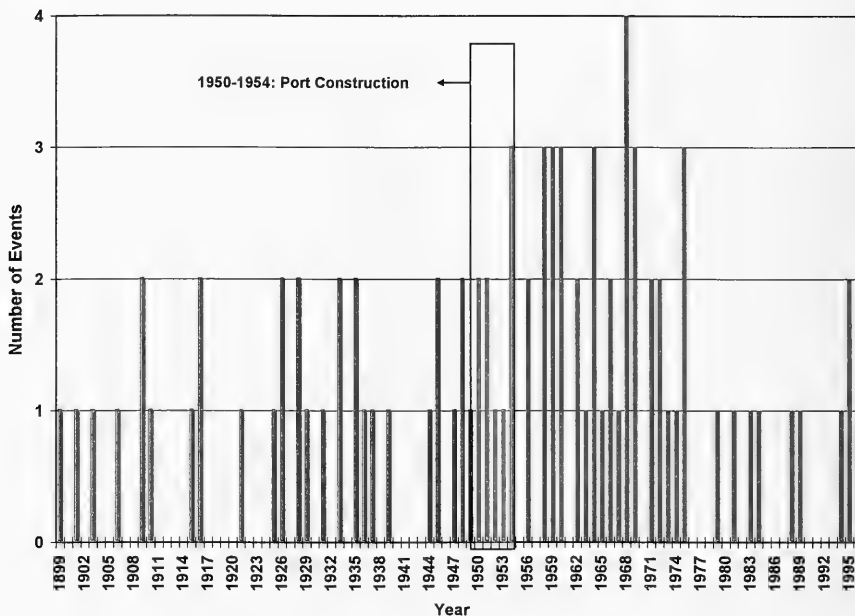
Figure 2-6. Number of tropical storms per year 1899 – 1996 documented as erosional to Brevard County beaches.

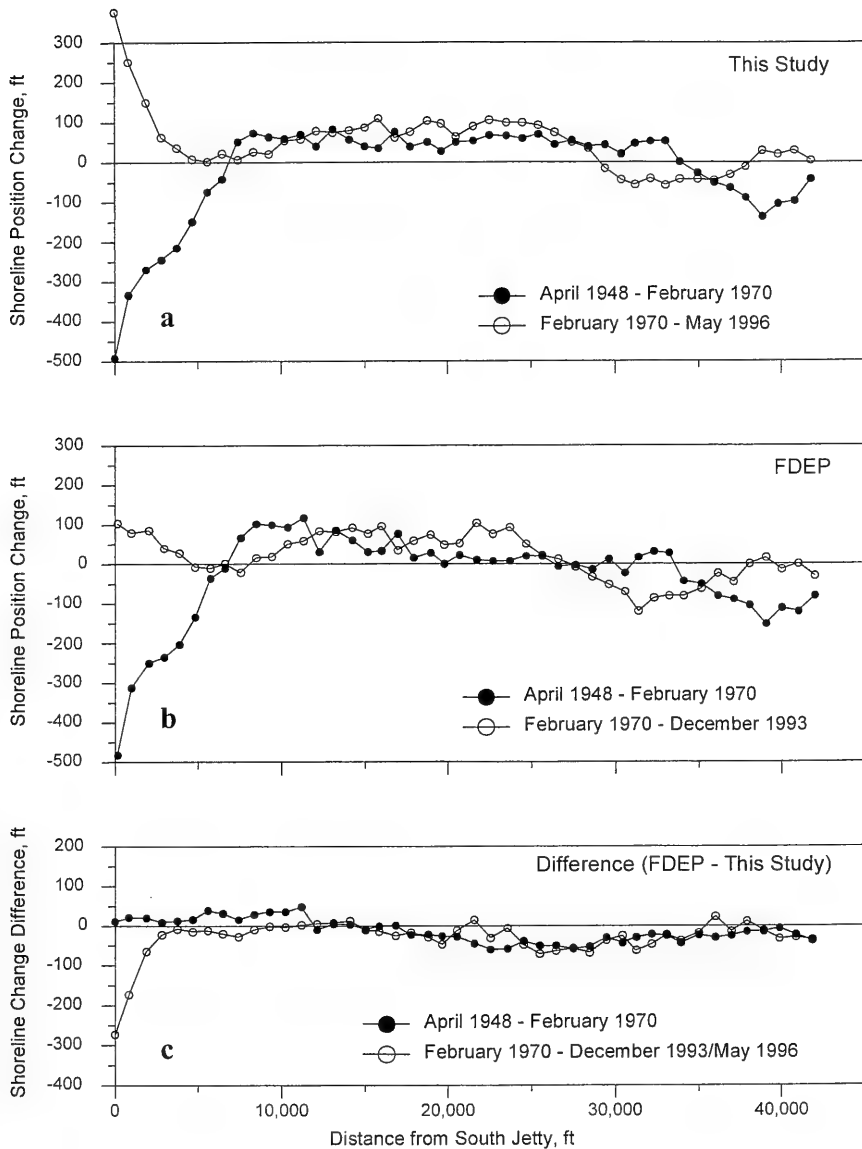
Figure 3-3. Shoreline-position change after Harbor construction from data sets analyzed (a) for this study and (b) from the FDEP.

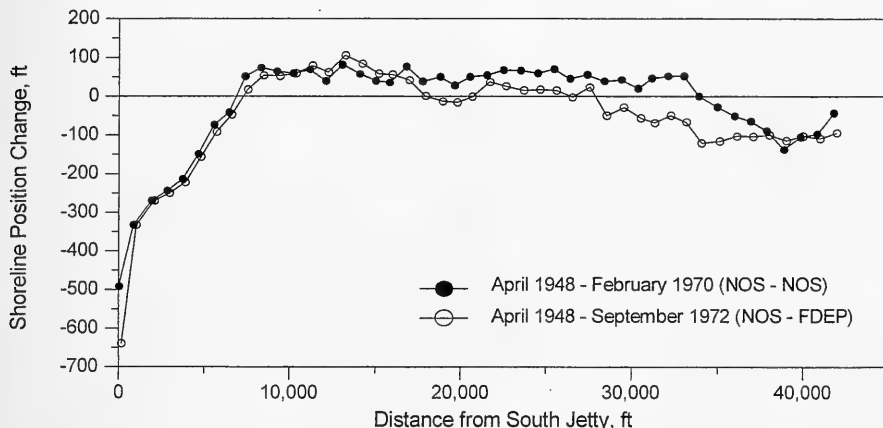
Figure 3-4. Shoreline-position change prior to the 1974/75 beach fill comparing beach response derived from NOS data to that derived from the 1948 NOS shoreline and the 1972 FDEP beach-profile data.

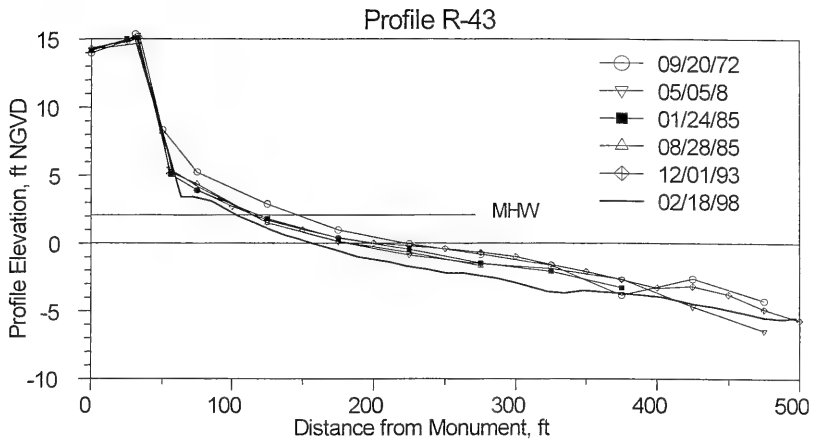
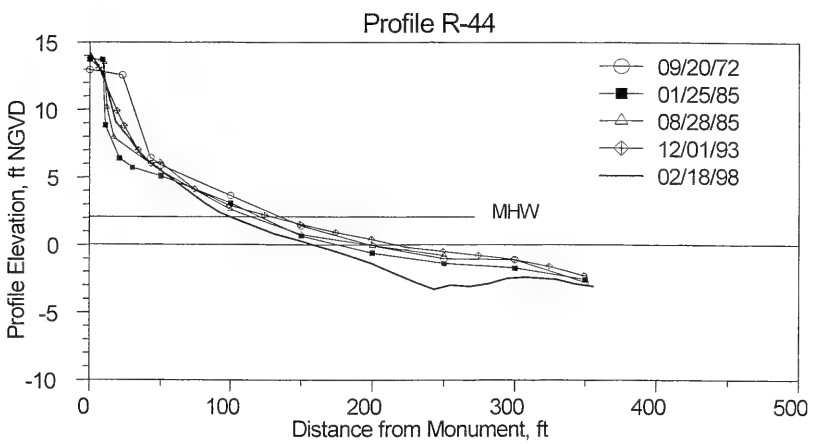
Figure 3-11. Beach profile change at FDEP Monuments R-43 and R-44.

Similar to beach changes recorded at R-7, where simulated storm impacts accounted for a significant portion of measured erosion and recession, all of the erosion on the upper beach (above 5 ft NGVD) and the dune face at R-43 and R-44 can be attributed to storm-induced erosion. Storm-induced beach-volume loss at Noro for the time of purchase is calculated from Table 3-6 as $(2.8+2.1 \text{ cy/ft}) \times 100 \text{ ft} = 490 \text{ cy}$.

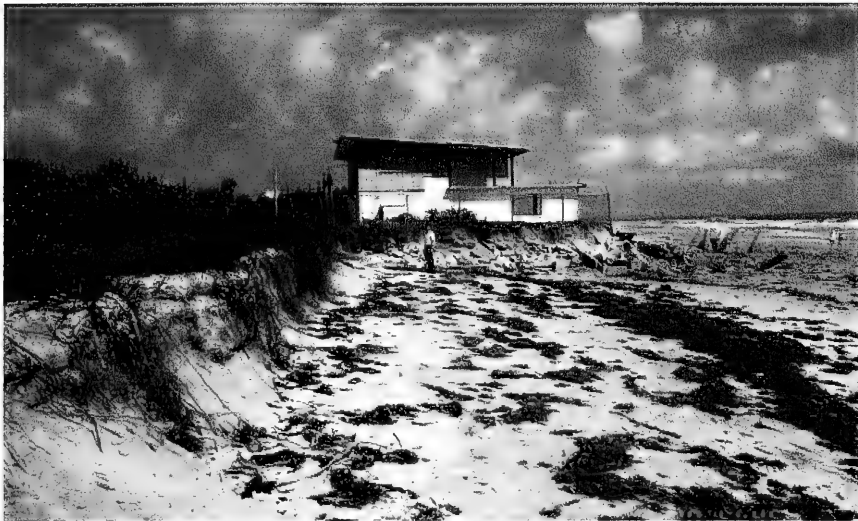
Figure 4-2. Applegate property viewed from the south adjacent property, February 20, 1997. Location of Applegate residence and rubble on the beach face and in front of the dune line is clearly evident (source: N. C. Kraus).

Don and Gale Applegate purchased their property in August 1981 for \$15,000. At the time of purchase, there was no dune in front of the structure, but much of the 1974/75 beach fill still remained. Figure 4-1 shows the location of the Applegate house relative to the dune line in August 1971, and Figure 1-2 shows almost the same view in May 1996. The house had been located approximately 200 ft seaward of all other houses south of the Harbor in Brevard County. In the 1960s, concrete rubble and automobile parts were placed in front of the property in an attempt to protect against storm waves and flooding (Figure 4-1 and Figure 4-2) and were still

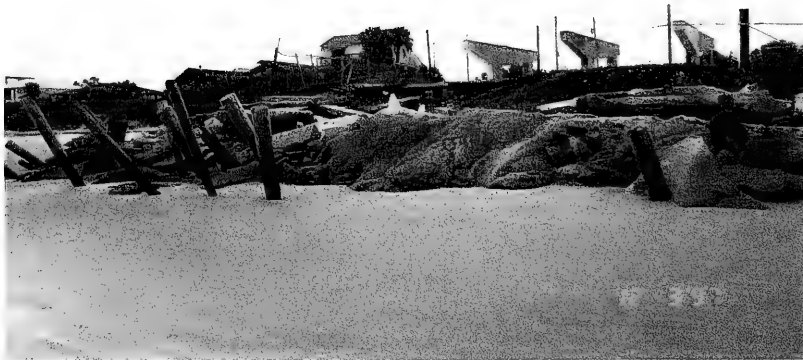
Figure 4-3. Seaward side of the Applegate property, December 3, 1997. Main structure was removed by Mr. Applegate around September 1997; however, the foundation of the dwelling and the rubble in front of the structure still remained (source: N. C. Kraus).

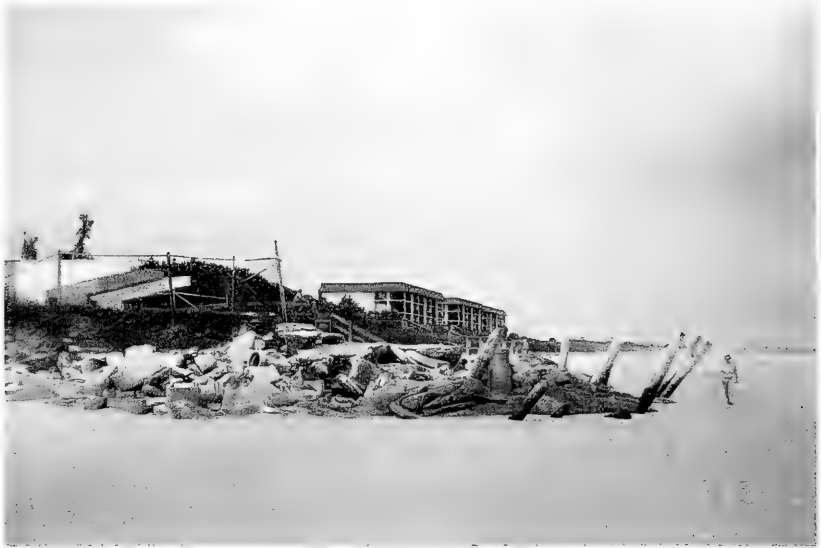
Figure 4-4. Side view of Applegate property, December 3, 1997 (source: N. C. Kraus).

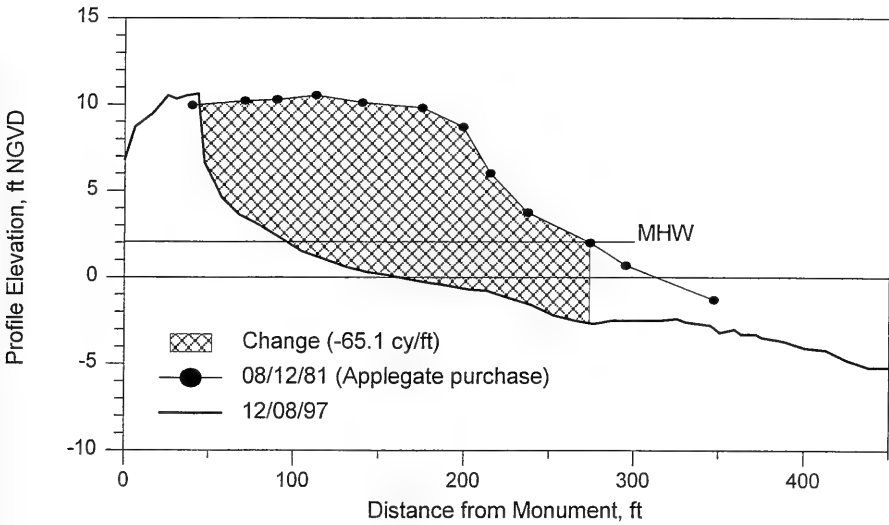
Profile R-8

Figure 4-6. Beach profile surveys at Monument R-8 and calculated volume loss from the time of purchase (August 12, 1981).

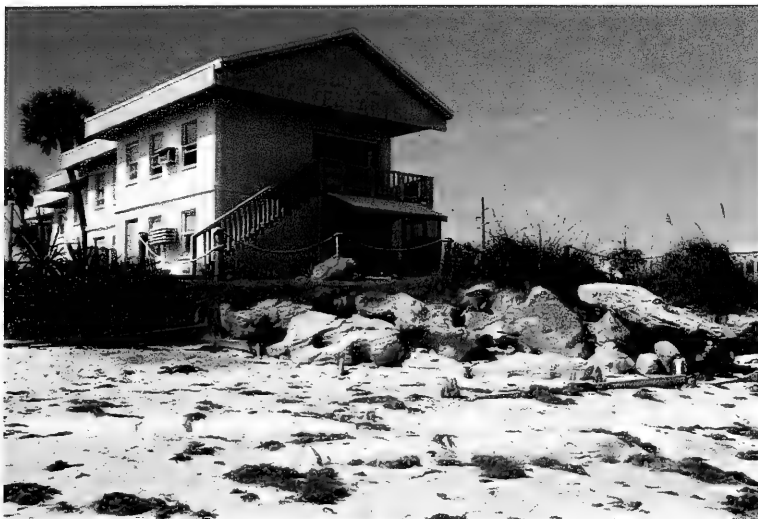
Figure 4-7. View of rock revetment and remnant wooden bulkhead seaward of the Pelican Landing Resort, February 20, 1997 (source: N. C. Kraus).

The 1984 Thanksgiving Day northeaster struck the coast of Brevard County 2 years before Noro purchased the property. This storm removed the beach, destroyed the wooden bulkhead built to protect the property against storm waves, and eroded the dunes at the site. A local newspaper (*Florida Today* 11/24/84) reported that the foundation of "Pelican Landing Resort in Cocoa Beach hangs over dunes edge..." after the Thanksgiving Day storm. The remains of the wooden bulkhead can be seen in Figures 4-7 and 4-8. This bulkhead indicates response to and anticipation of dune erosion caused by storms, because long-term change of the MHW shoreline has been negligible for at least 30 years. During low tide, a substantial beach is observed in front of the Noro property, as seen in Figure 4-9.

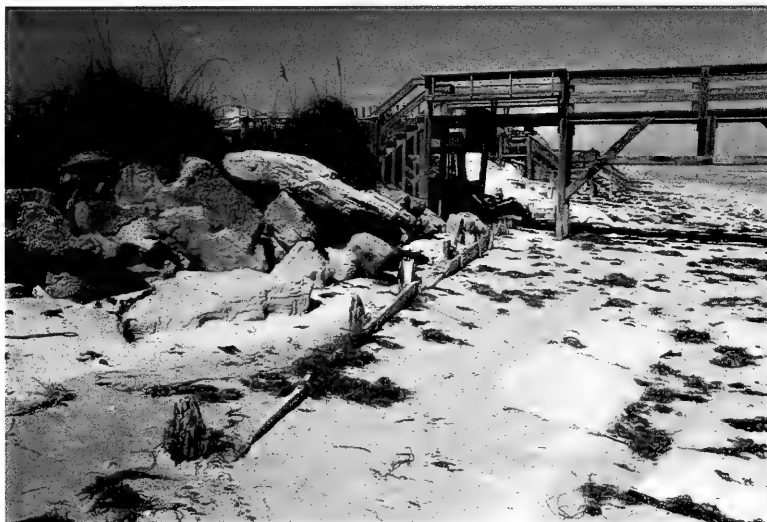
Figure 4-8. Oblique view of remnant wooden bulkhead, rock revetment, and sandbags along the seaward side of the Noro Property (Pelican Landing), February 20, 1997 (source: N. C. Kraus).

The northern border of the property is located 395 ft south of Monument R-43, and the property is 100 ft wide. The adjacent beach properties in this area are mostly armored. Presently, the Noro property is protected by sandbags (geotextile armoring units) placed around its seaward perimeter, and remnants of a rock revetment (or rubble) and a wooden bulkhead can be observed (see Figures 4-7 and 4-8). The bulkhead protected the property prior to the time of purchase, but it was destroyed in the Thanksgiving Day northeaster of 1984.

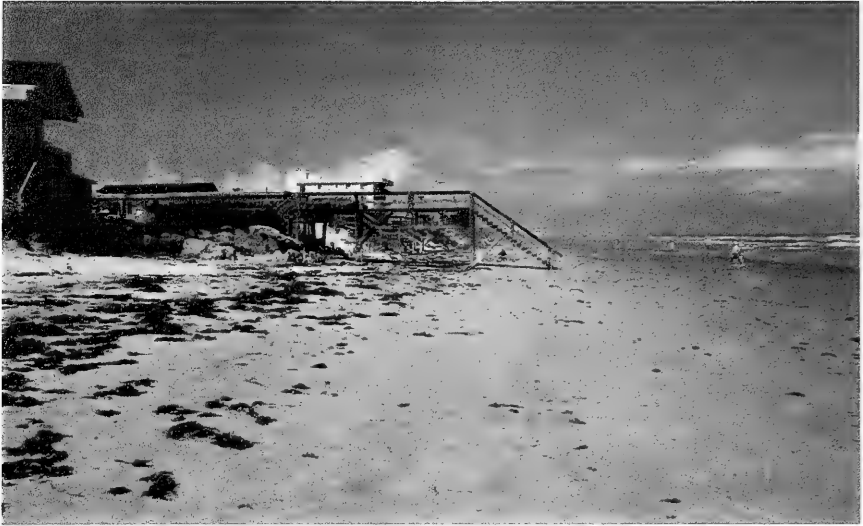
Figure 4-9. View north of Noro property with a wide beach, February 20, 1997 (source: N.C. Kraus).

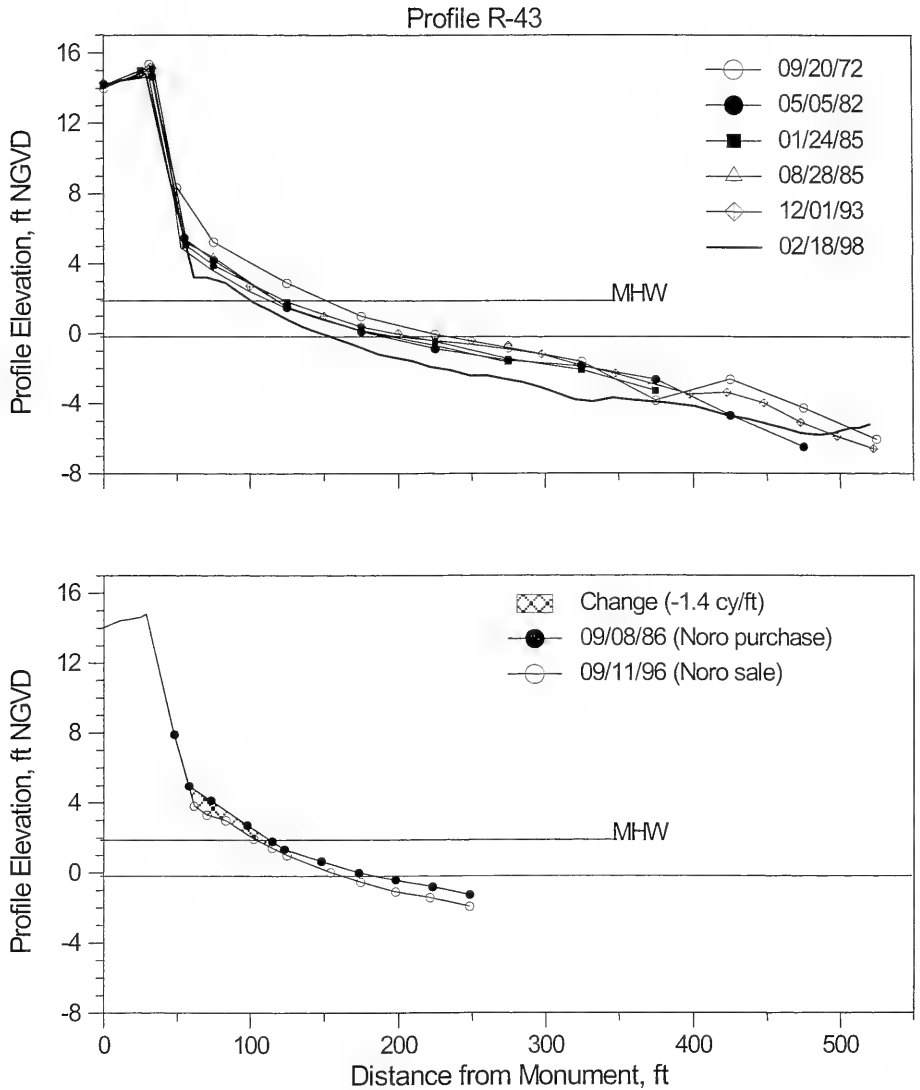
Figure 4-10. Beach-profile surveys at Monument R-43 and calculated volume loss from the time of purchase (August 12, 1981).

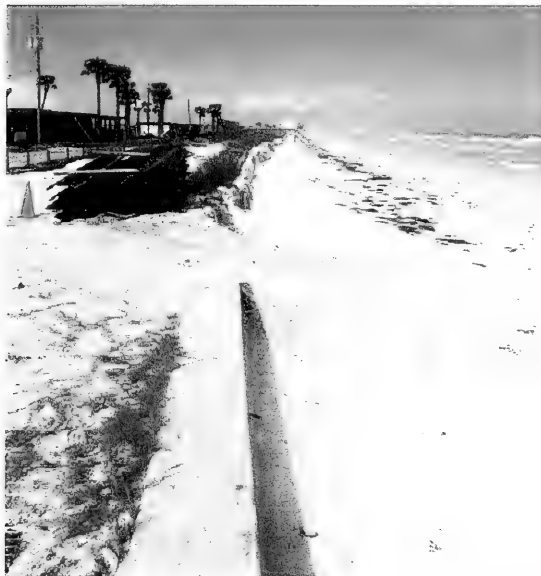
Figure D-1: View north along the concrete bulkhead at the Officers Club, Patrick AFB, February 20, 1997 (source: N. C. Kraus).

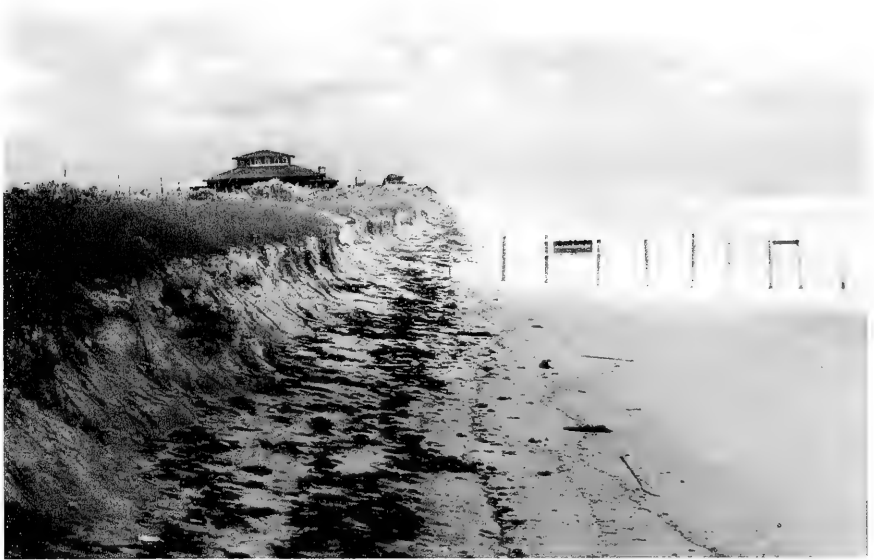
Figure D-2: Canaveral National Seashore at the Brevard/Volusia County line on September 6, 1979, showing storm damage to the dunes from Hurricane David (source: USACE, Jacksonville District).

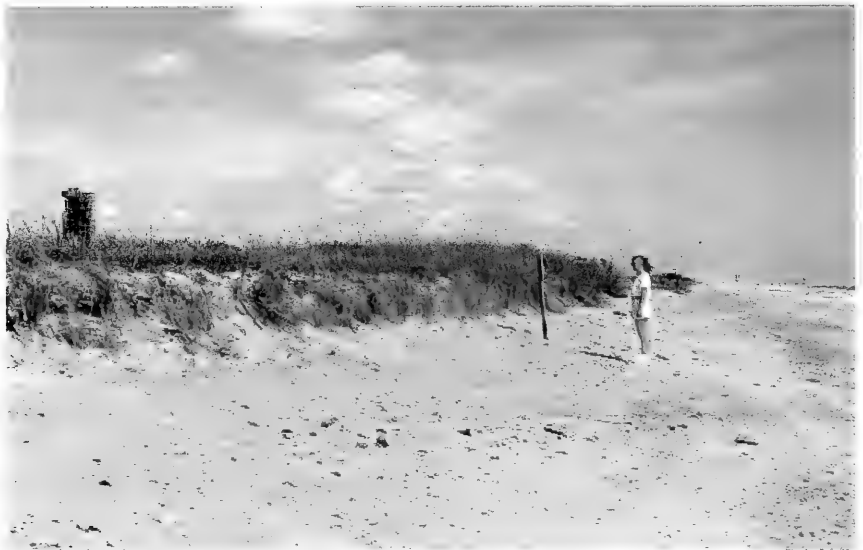
Figure D-3: NASA Federal Property at the tip of Cape Canaveral on May 10, 1996. Damage to the dunes from past storms is still visible (source: N. C. Kraus).

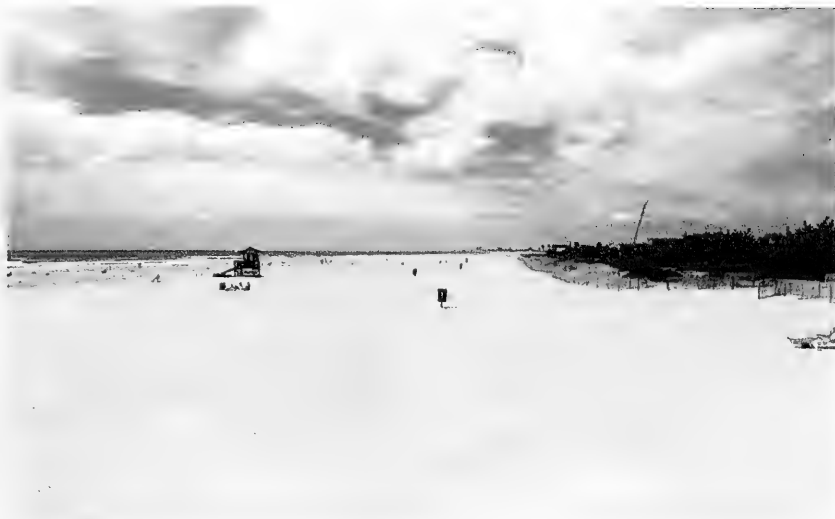
Figure D-4: View of Jetty Park just south of the South Jetty on May 9, 1996. A beach nourishment project was constructed in January 1996 (source: N. C. Kraus).

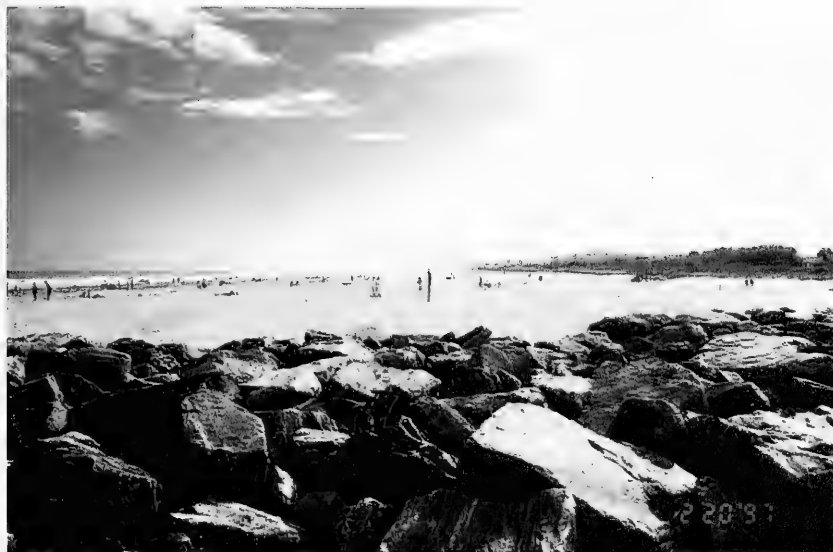
Figure D-5: View of Jetty Park south of the South Jetty on February 20, 1997; one year after beach nourishment project (source: N. C. Kraus).

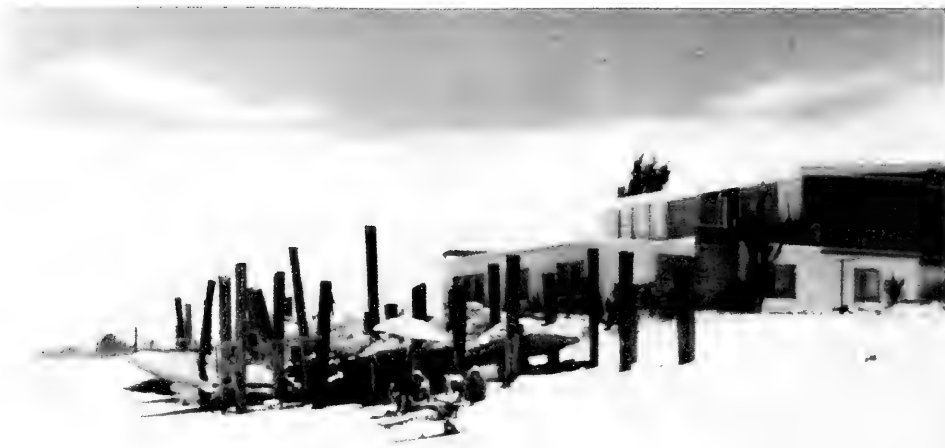
Figure D-6: Applegate property, August 1971. Presence of pilings and concrete rubble indicates this particular house was vulnerable to wave impacts soon after its construction, circa 1960 (source: USACE, Jacksonville District).

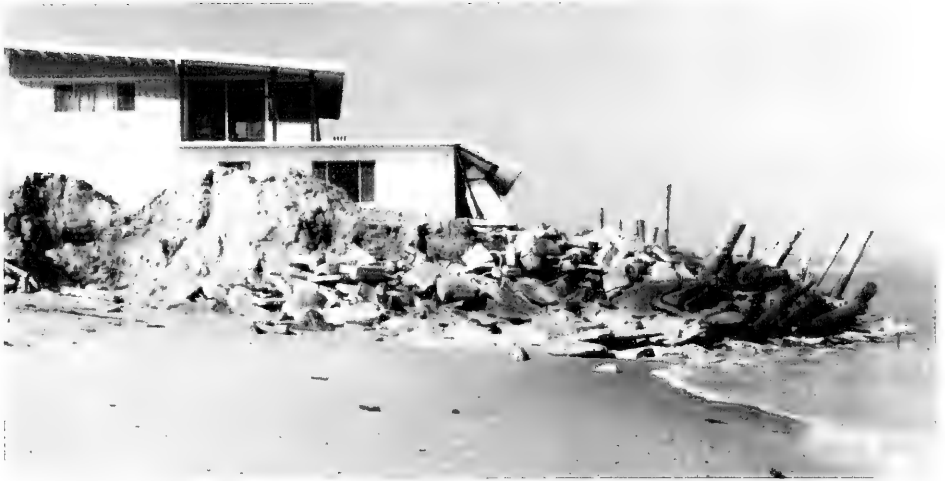
Figure D-8: South side of Applegate property between February 1973 and November 1974
(source: USACE, Jacksonville District).

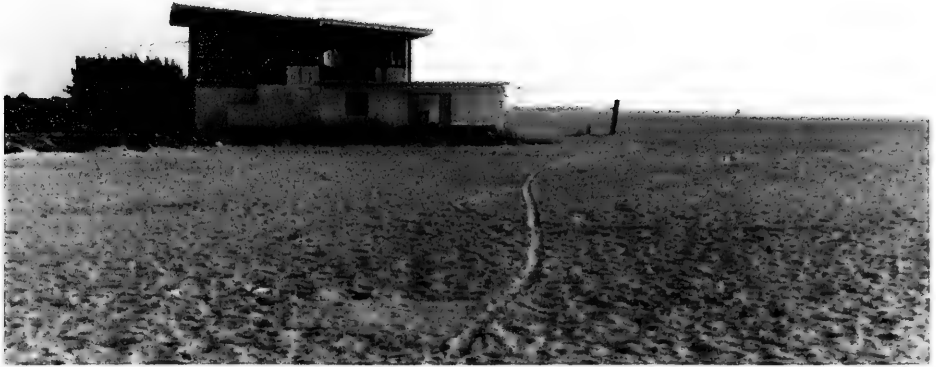
Figure D-10: Viewing north at Applegate property photographed after the USACE 1974/75 beach fill (source: USACE, Jacksonville District).

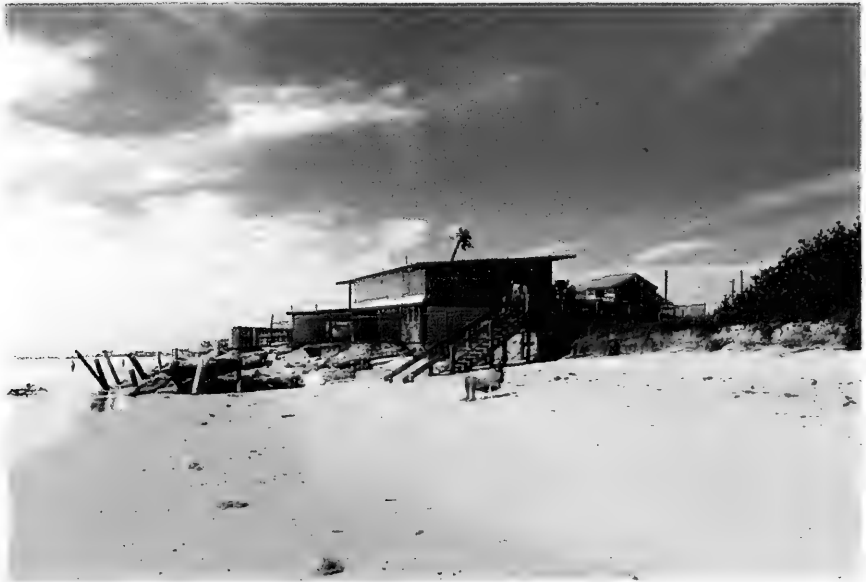
Figure D-11: Applegate property on May 9, 1996, showing location of rubble mound and structure relative to natural beach features and other structures along the coast (source: N. C. Kraus).

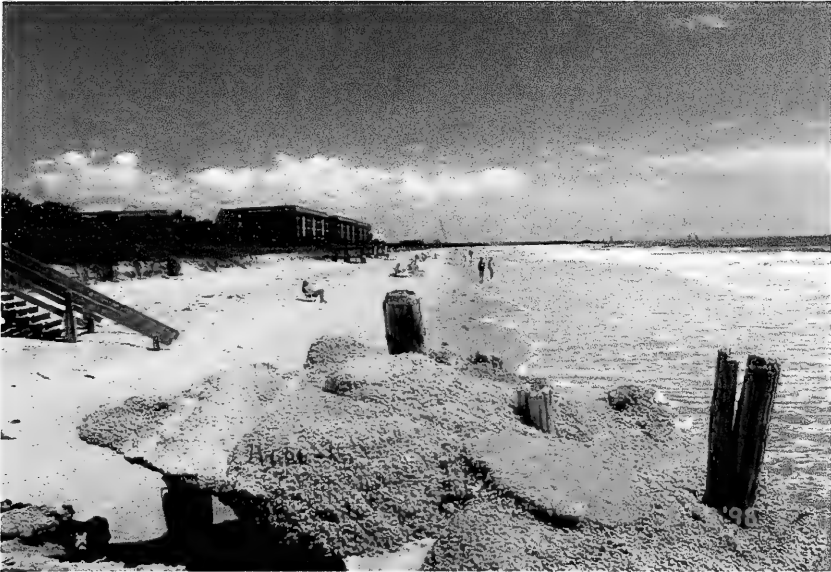
Figure D-12: View looking north from Applegate residence, May 9, 1996 (source: N. C. Kraus).

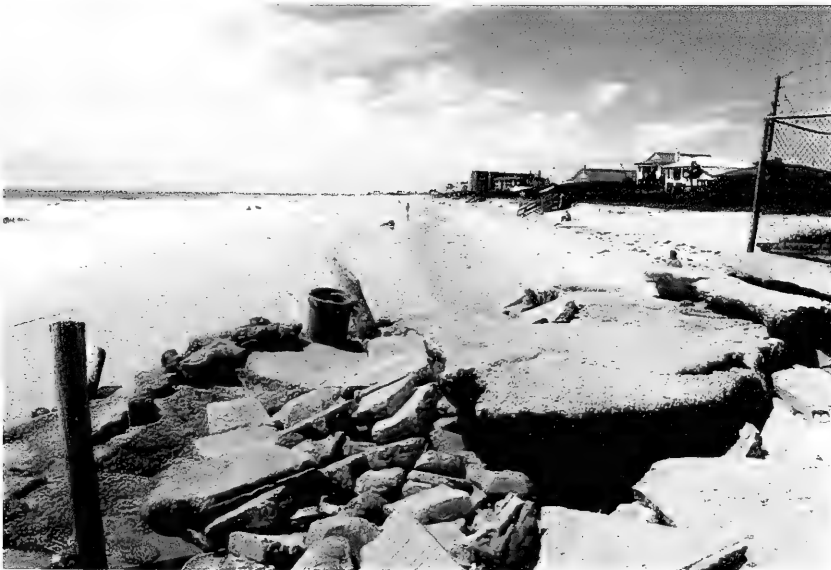
Figure D-13: View looking south from Applegate residence, May 9, 1996 (source: N. C. Kraus).

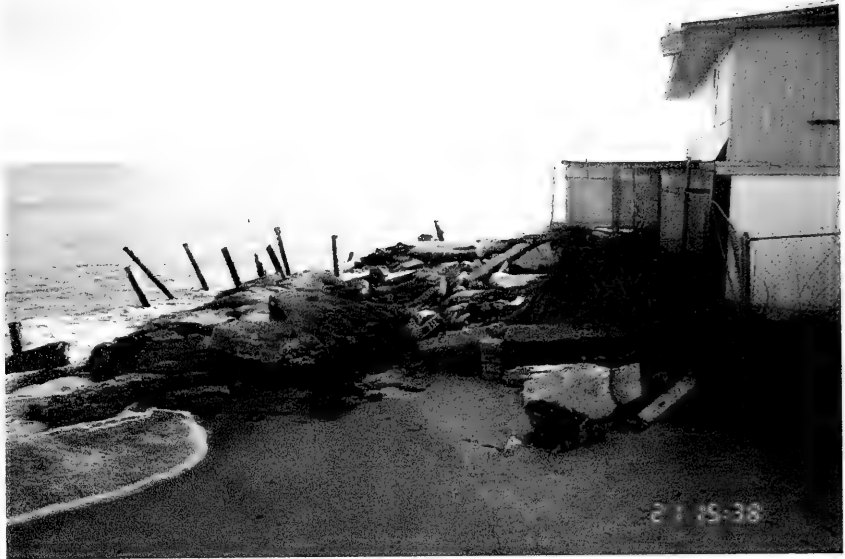
Figure D-14: Applegate property, November 21, 1996. Winter beach condition has uncovered more rubble and debris seaward of the house. Rusted vehicle parts can be seen in the foreground (source: N. C. Kraus).

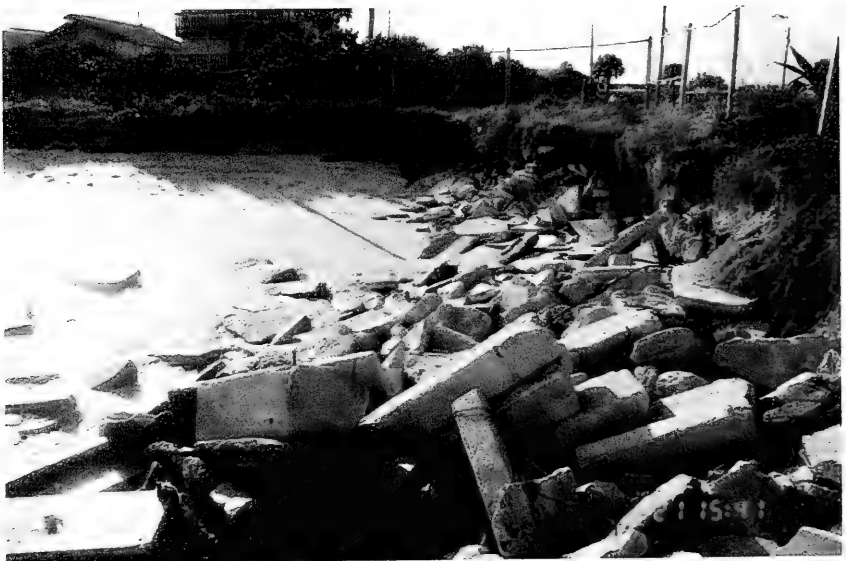
Figure D-15: Southern property boundary of Applegate residence, November 21, 1996, showing downdrift impacts of rubble mound seaward of the structure (source: N. C. Kraus).

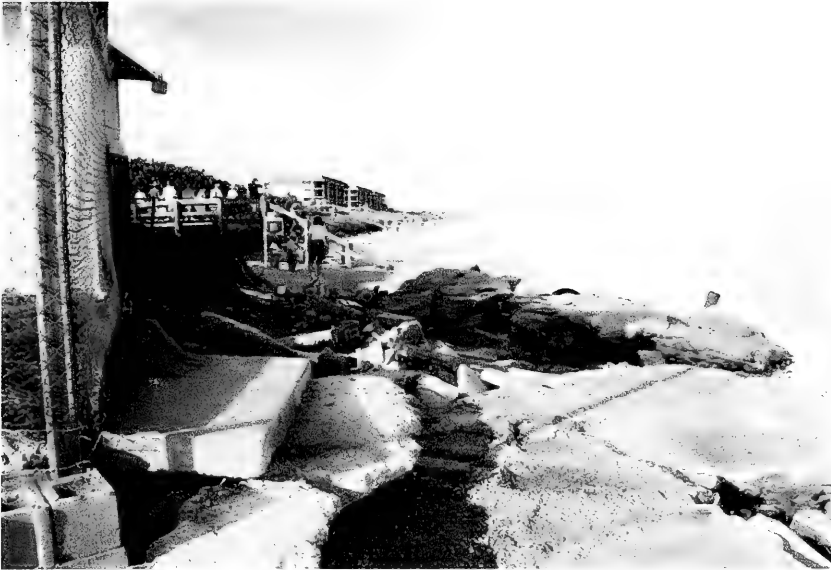
Figure D-16: Northern view from Applegate's property, November 21, 1996, showing the narrow beach associated with a typical winter beach profile (source: N. C. Kraus) .

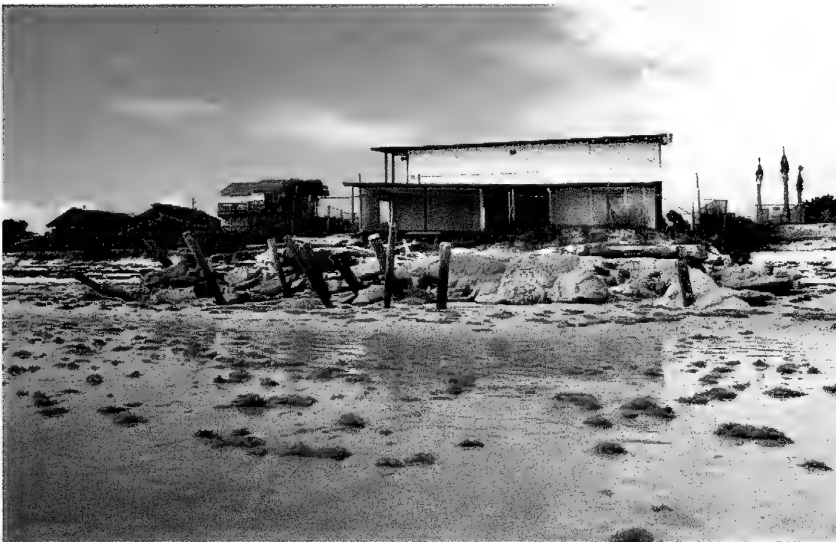
Figure D-17: Applegate property, February 20, 1997 (source: N. C. Kraus).

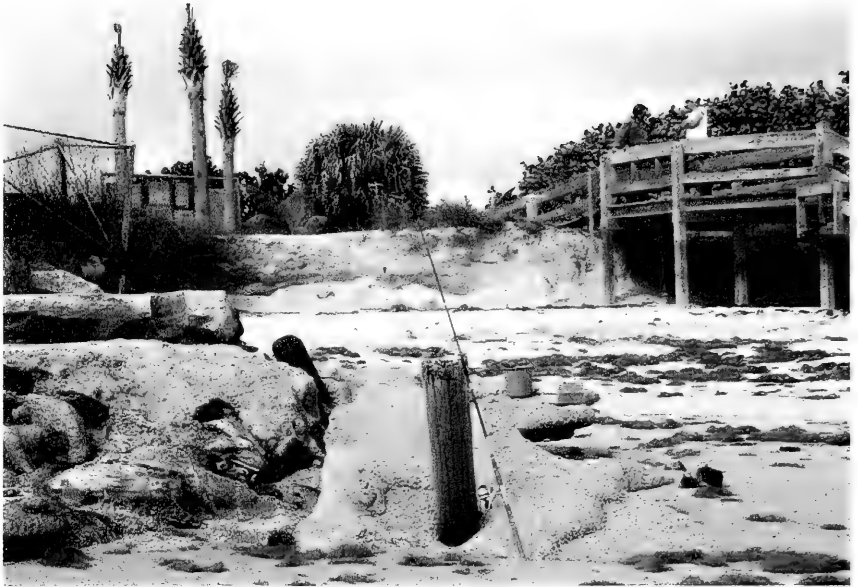
Figure D-18: Dune face directly north of Applegate property, February 20, 1997, indicating storm erosion (source: N. C. Kraus).

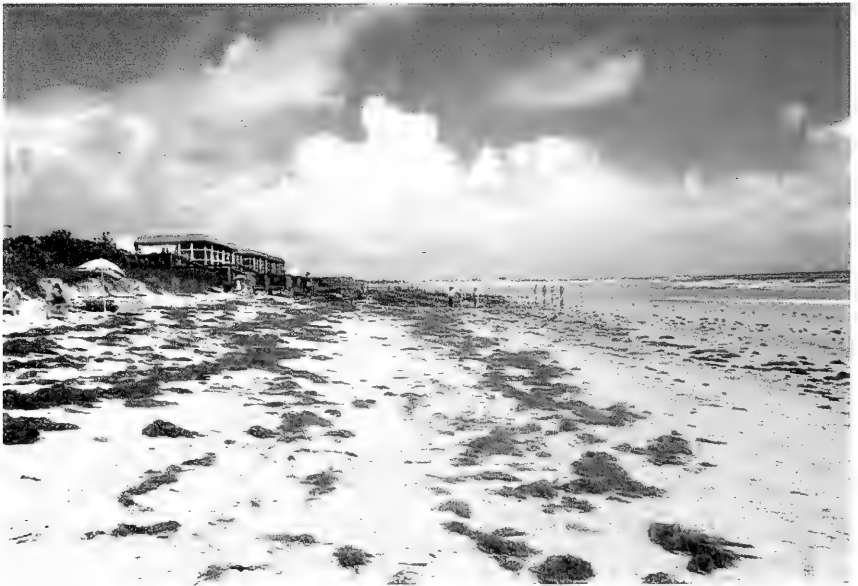
Figure D-19: View north from Applegate property, February 20, 1997 (source: N. C. Kraus).

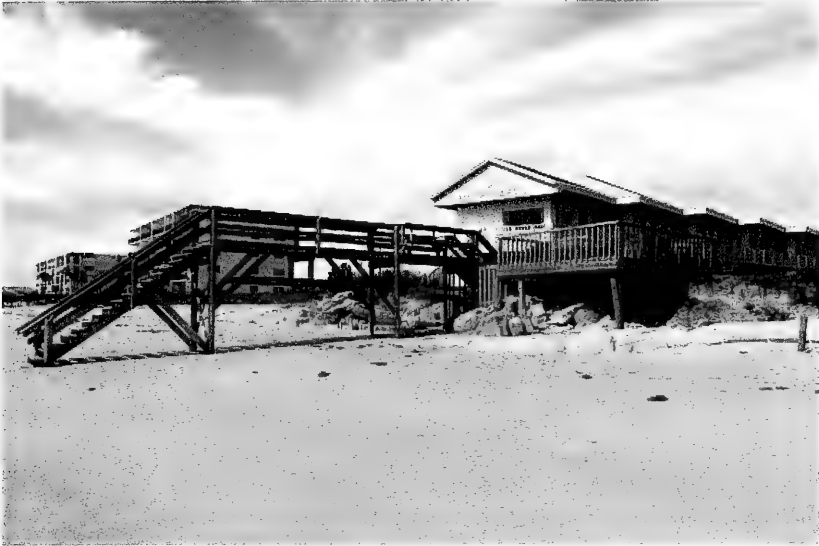
Figure D-20: Noro and Co. property, May 9, 1996. Note the old stone revetment, deteriorated wooden bulkhead, and the sandbags along the seaward side of the property under the wooden boardwalk (source: N. C. Kraus).

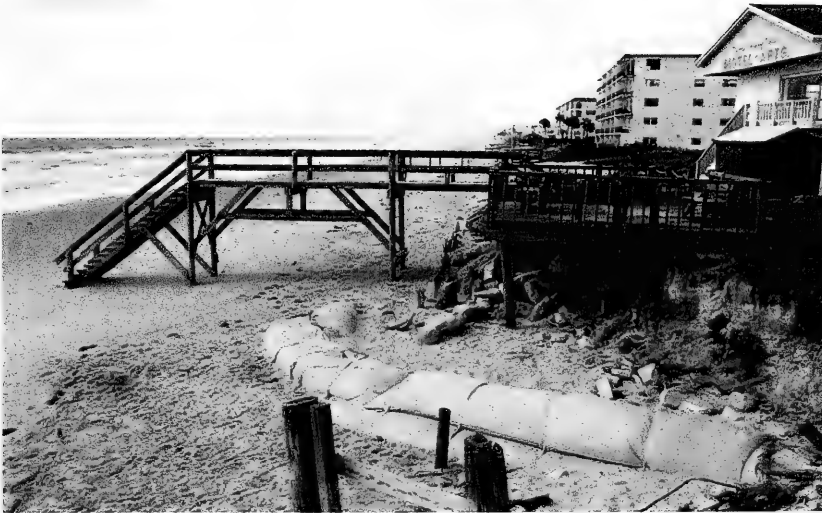
Figure D-21: Noro and Co. property, May 9, 1996, showing the deteriorated wooden bulkhead and geotextile sandbags, as well as storm-induced erosion to the dune face (source: N. C. Kraus).

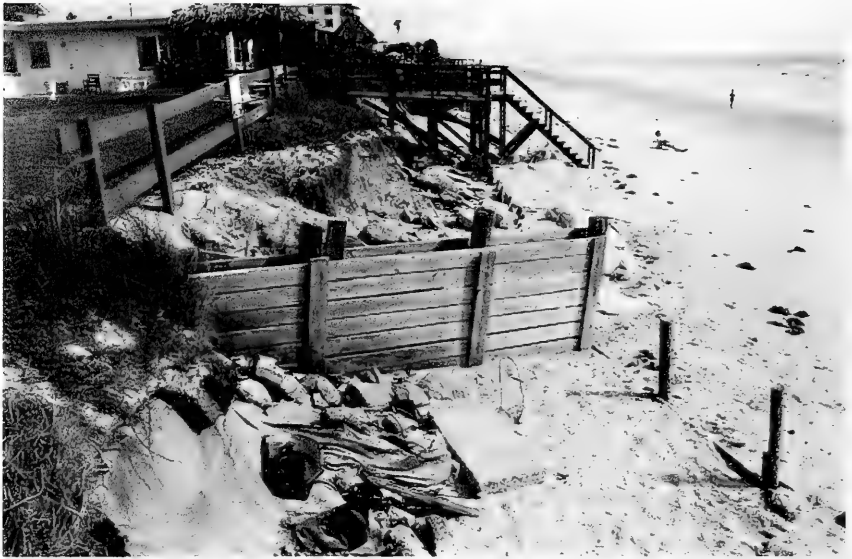
Figure D-22: View north from Noro and Co. property, May 9, 1996, showing storm damage to the dunes and the remains of attempts to protect upland properties (source: N. C. Kraus).

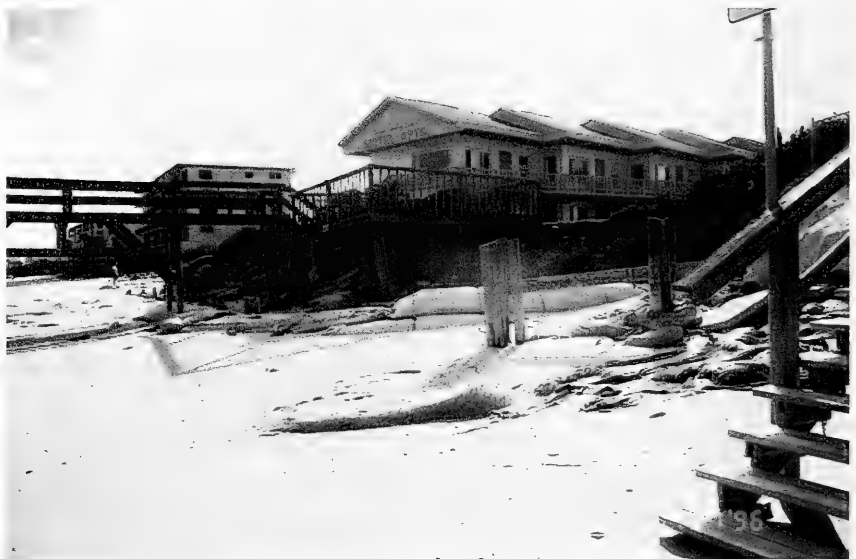
Figure D-23: Noro and Co. property, November 21, 1996, showing deteriorated wooden bulkhead, geotextile sandbags, and other remains of storm-protection structures (source: N. C. Kraus).

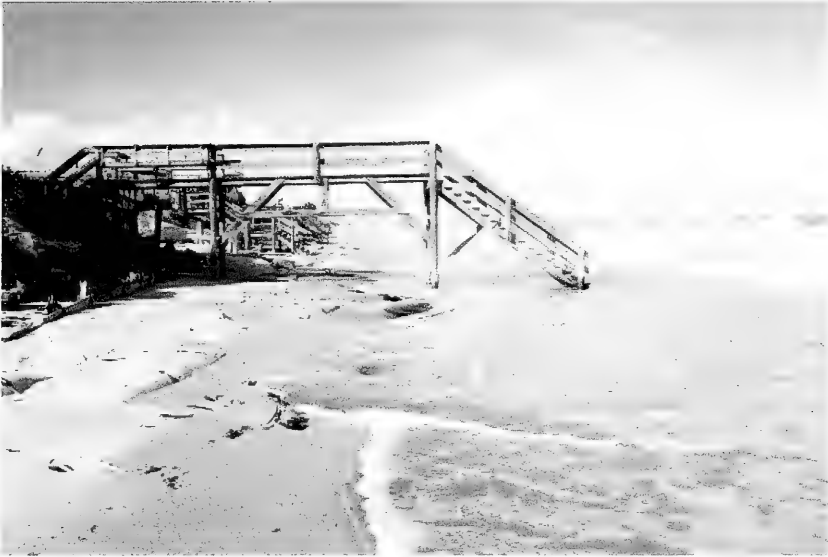
Figure D-24: View north of the boardwalk at Noro and Co. property, November 21, 1996, showing the narrow beach associated with a typical winter profile (source: N. C. Kraus).

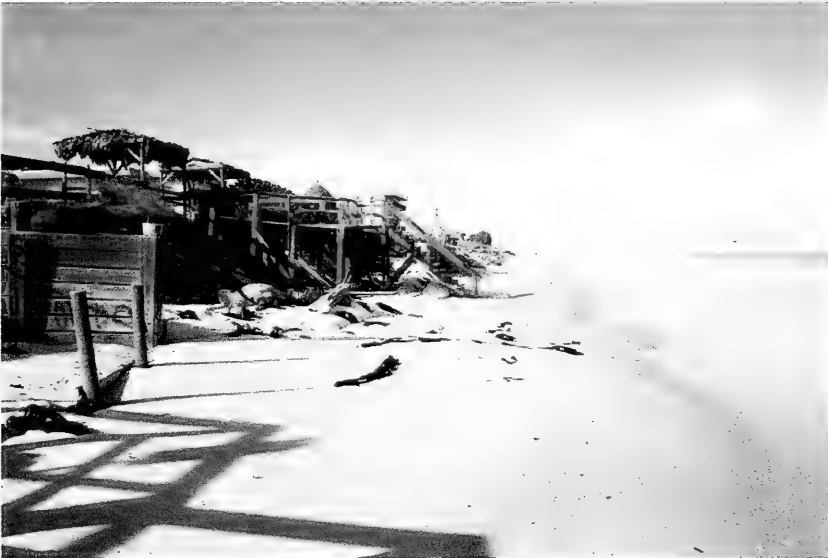
Figure D-25: View north of Noro and Co. property, November 21, 1996, showing storm damages to northern neighboring properties (source: N. C. Kraus).

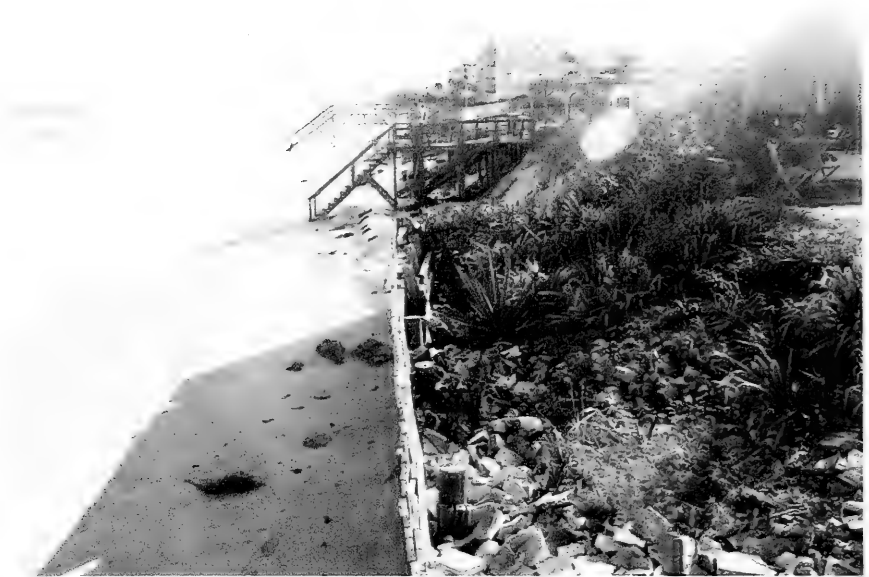
Figure D-26: View south towards Noro property showing the eroded dunes on one property and the creative armoring structures on the neighboring property to the north (source: N. C. Kraus).

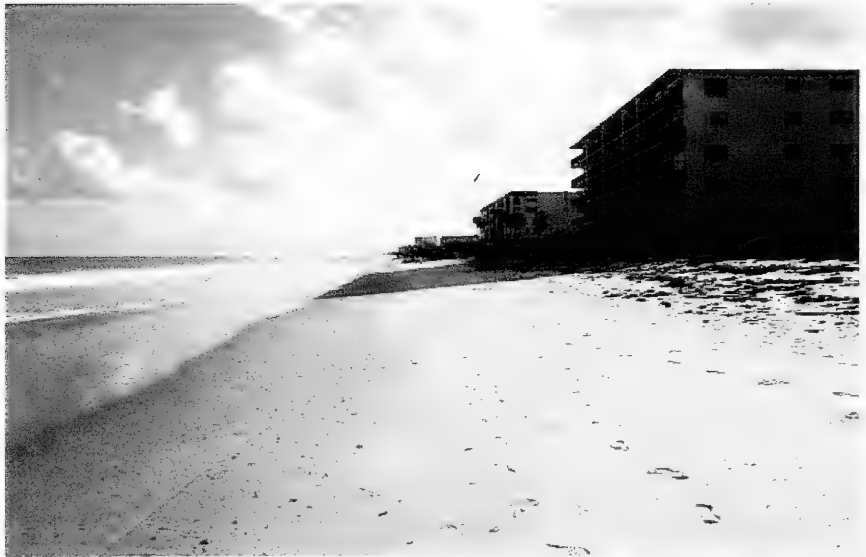
Figure D-27: View south from Noro and Co. property showing a wider beach, November 21, 1996 (source: N. C. Kraus).

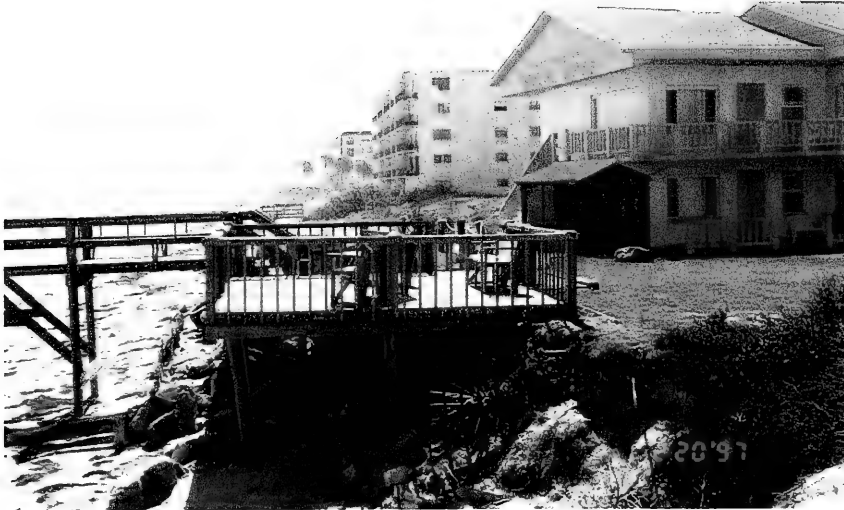
Figure D-28: Noro and Co. property, February 20, 1997. The remains of the wooden bulkhead are visible just seaward of the wooden deck (source: N. C. Kraus).

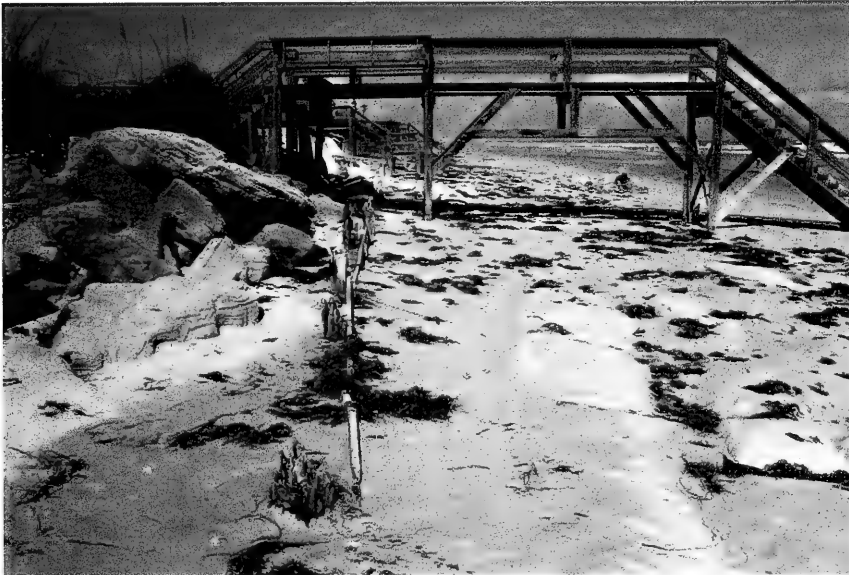
Figure D-29: View north of Noro and Co. property showing the remains of the wooden bulkhead and rock revetment, February 20, 1997(source: N. C. Kraus).
